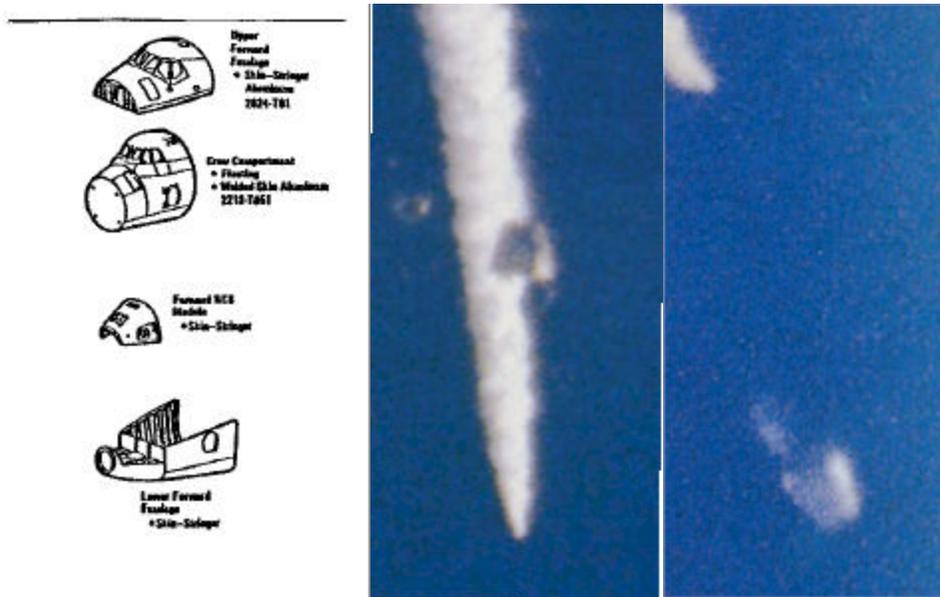
The photo at center is the “mjanovec’s” post, and another supposedly Crew Cabin photo (same source) is on the right. On the left, four forward Orbiter modules are shown, from top to bottom: (1) Upper Forward Fuselage, (2) Crew Compartment (CC), (3) Forward RCS Module, and (4) Lower Forward Fuselage (LFF). All one needs is good lighting to make out the piece in the photos. It is the LFF without the lower forward lip section. Read my post #104 about the shadows and the order of recovery of the LFF by the Search and Recovery Team. Also, notice the rise, or slant, of the windows in the Upper Forward Fuselage and the CC. The supposed “CC” in the photos below, and video, does not show the slope or the windows at any angle!

The piece in these and similar photos is the Lower Forward Fuselage, NOT the Crew Cabin.
