Back to some photos. The reviews of Tim Furniss' Challenger Chapter on this thread and elsewhere were cruel. Tim writes of fire at lift-off, continued leak from the stricken booster, debris falling in flight, the censored "New Smyrna Beach" tape and the Crew Cabin. Here are some photos that explain the "other sequence of events" that I developed in 1986.

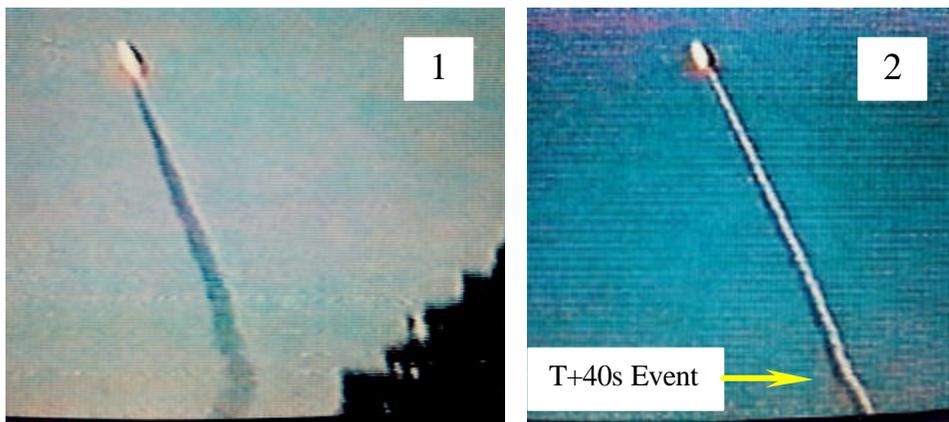
1. Here, you see the "roll maneuver" at the lower part. Notice that the two plumes blended into one plume, which I call the main plume.
2. At T+40 seconds, Challenger executed a sudden upward turn – to counter excessive speed. At this time, puffs of smoke become visible to the left of the main plume (or, the combined left and right plumes).
3. The puffs of smoke are clearly visible to the left of the main plume (T+50s<sup>+</sup>).
4. The puffs increase in intensity and coalesce into a semi-continuous trail (T+57s<sup>+</sup>).
5. After T+71 seconds, the leaking trail (on the left) takes on the form of a distinct plume. The two plumes in Photo #5 are NOT the two plumes of the right and left SRBs; rather the main plume on the right side is the two plumes of the right and left boosters and the plume on the left side is the leak footprint.

From the sequence you see above, it is evident that the stricken right booster on Challenger was leaking hot gases throughout flight. If you only saw the New Smyrna Beach tape from T+71s (Photo #5), you could easily conclude that all was well. For example, you might think there were two boosters and you see two plumes, i.e., the plume on the right belongs to the left booster and the left plume belongs to the stricken right SRB. Not so. After T+71 seconds (Photo #5), the plume on the right belongs to both the left and right SRBs (the main plume) and the plume on the left is a third plume – the leak trail.

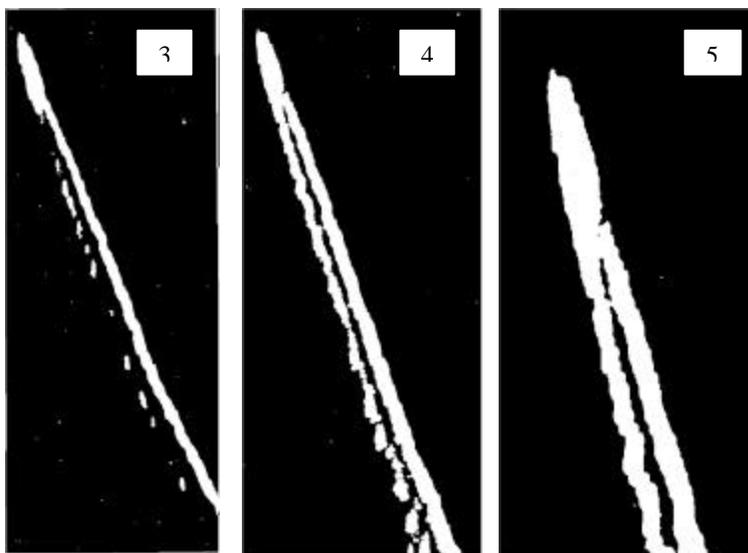
My NSB Photos 2, 3 and 4 clearly show "observable plume" before 59 seconds. My close-up photos, and video, give further convincing evidence, but I have to manage the file size for now.

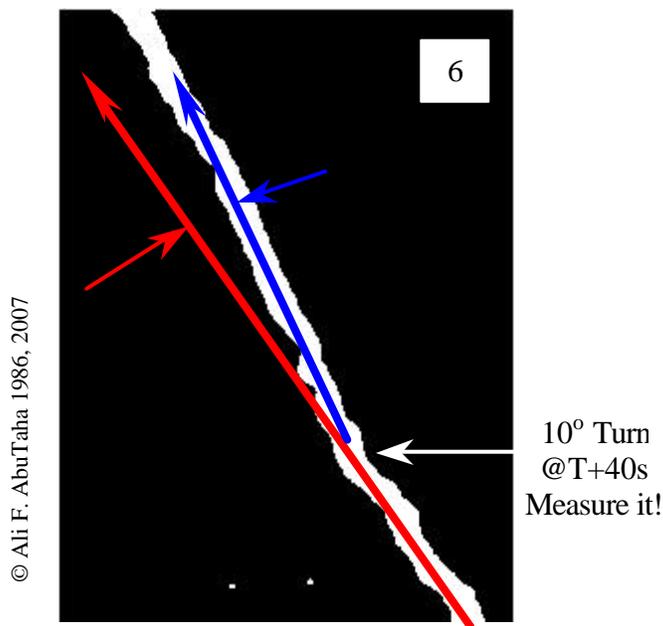
A picture is worth a thousand words, and here is such a picture. I had taken a close-up of the 40-second event (Photo #6); and the average of measurements made by the engineers attending my Challenger course at the George Washington University was 10-degrees. You can measure the angle that Challenger made at T+40s directly from my photo with a simple protractor. Is it that simple? Yes. The Shuttle is driven through its center of gravity. When the nozzles turn, the stack turns on a dime, more like a London Cab than a New York Taxi.

A sudden 10-degree turn is a Major Event, but it is not listed in the “**STS 51-L Sequence of Major Events**” Table in the Commission, Vol. I, page 37! Before T+40s, the SSMEs had throttled down to 65% in the bucket, but the assembly was moving alarmingly fast, and the onboard computers, to counter the unexpected speed, executed the major 10° turn. The faster than normal speed would have resulted from the uneven burning of propellant in the stricken right booster aft segments, which I mentioned before.
