Between T+50 and T+60 seconds, only one major event is listed in the official “**STS 51-L Sequence of Major Events**,” (Commission, Vol. I, p. 37): The appearance of “flame on RH SRM” at T+58.788 seconds. Yet for the same interval, I had discovered numerous “Major Events” as described below.

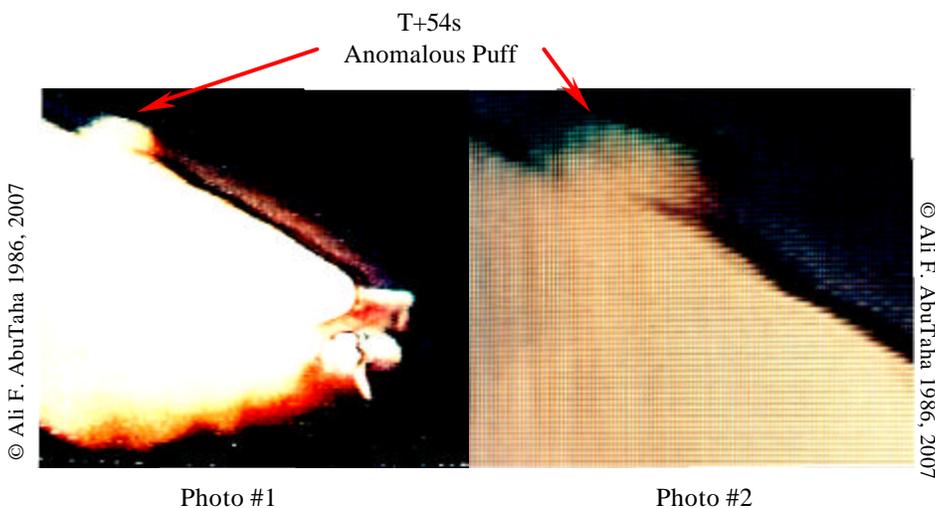
Photos #1 and 2 show an anomalous puff of exhaust that projected “upward” from the far side, or the right SRB side, at T+54 seconds. Some NASA experts said that that was a plume feature. I had not seen that before, not on the belly side, which exhibits smoother aerodynamics.

The two puffs in Photo #4 indicate that either the initial puff (in Photos #1-3) broke up in two, or that there were two independent puffs that initially overlapped and appeared as one puff. I favor the second explanation for the reasons and further evidence described below.

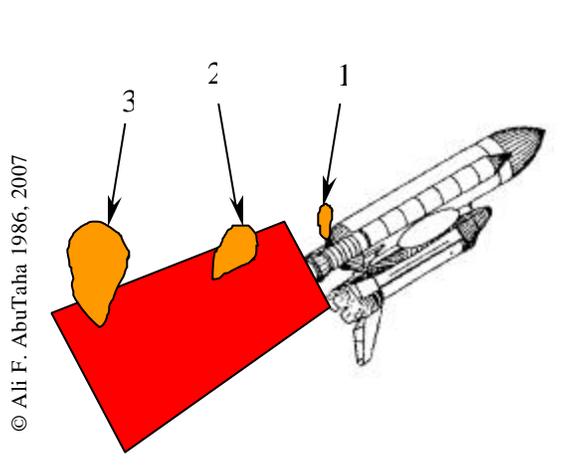
Sketch #1 – Source of odd Puff(s)

My Sketch #1 helps to visualize what might have happened. At 1, one or two pieces of the right booster's aft-walls ripped off, which caused the emergence of the 2 puffs. At 2, the two puffs were hidden by the plume (red) and not captured on film from that camera. At 3, the two puffs overlapped and emerged as one puff. Down stream (Photo #4), the two puffs became distinctly visible.

Not even magical wind can explain the appearance and progress of the T+54s puff(s). A chunk of propellant flying out of the right booster might be proposed, but that is highly unlikely. Such mass would tend to sink downward and disappear in the main plume. I also captured the T+54s puff(s) in the New Smyrna Beach and other views.

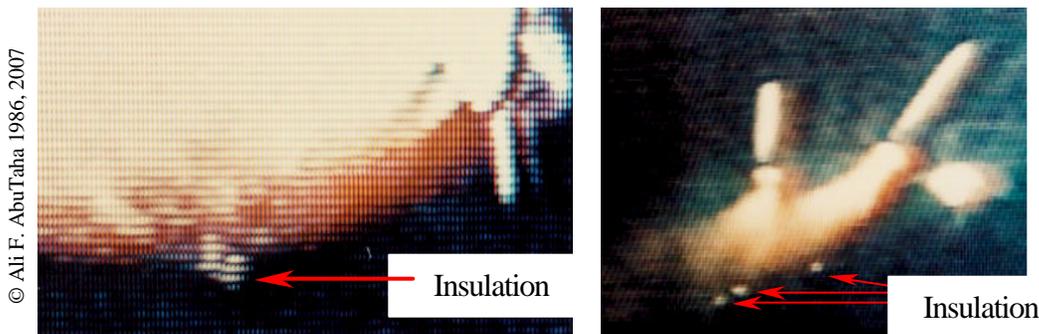
Photo #8: Challenger @T+60 seconds

At T+60s, I captured several white pieces flying at the edge of the plume, as you see in Photo #8. Now these are similar to “plume features” that were seen in the past. Photo #9 shows similar white pieces flying at the edge of the boosters’ plumes at SRB separation in a previous Shuttle mission. Specifically, these are “insulation” pieces stripped off in areas where the propellant was completely consumed.

Photo #9: STS @ SRBs' burnout

What does the appearance of “insulation” pieces at T+60s mean? It means that some of the propellant in the stricken right aft segments was consumed a minute after lift off. This is the source of the energy that drove Challenger alarmingly faster than projected before the T+40s event, which I described in my last Post. Most of the recovered forward segment pieces still had 2-4 inches of unburned propellant left near the walls. Yet, if you carefully read the reports of the Search, Recovery and Reconstructions Teams, you will find that the RSRB aft segments had no propellant left in them at all, e.g., for pieces #21-1, “*there was no propellant on this piece,*” #21-2, “*There was no propellant on this part,*” #21-3, “*There is no propellant on the part,*” #21-5, “*There is no propellant on this piece,*” and so on (Commission, Vol. III, p. O-272).
