The Problem with the Space Shuttle and the Space Program
Ali F. AbuTaha
Fairfax, VA
1992, 2000, 2003

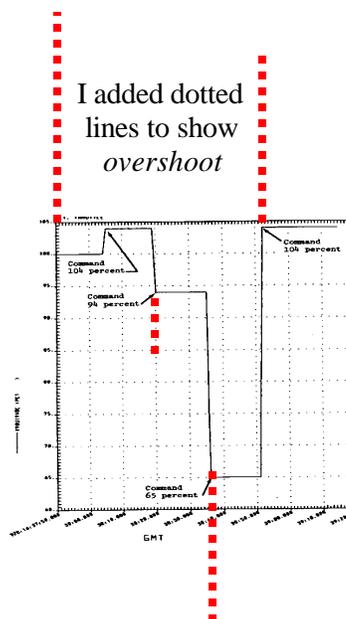
Fig. 6 SSME's Throttle-up and Throttle-down Commands do not Show Overshoot

In thousands of graphic illustrations of the SSME's *dynamics* (in books, specifications and peer-reviewed journals), the correct *dynamic overshoot* is simply missing. The SSME's thrust is represented graphically as in Fig. 6, without the overshoot dotted lines. The engines throttle up to the 100% RPL (Rated Power Level), throttle down to another level, throttle up again to 104% level, and so on. *No dynamic overshoot* whatever. The same is true for the other Space Shuttle thrusters, and many other modern systems. I have added the *overshoot* with the dotted lines in Fig. 6.

The correct dynamic overshoot factor of more than 70% was missing in the 1972 JSC specification (Fig. 6 and Tables-3 and -4), and it was missing ten years later, in 1982, in the Rockwell dynamic loads illustration (Fig. 7). The wrong practice continued.

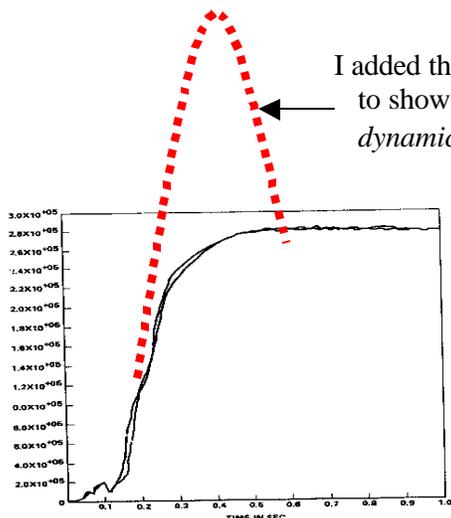
Fig. 11a 1981 NASA Illustration of SRB Thrust for 2 boosters. No *Overshoot*.

The practice of neglecting the *dynamic overshoot* in SRB design persisted over the years. It began with the 1972 NASA specifications and continued to this day (1992). Fig. 11a is a 1981 NASA graph which shows the "*SRB <u>thrust</u> difference between two motors*"[17] in the first second after *ignition.* The engineers were concerned, and rightfully so, about the differences in thrust between the left and the right boosters. The difference that the engineers were studying is orders of magnitude smaller than the dynamic overshoot, but the overshoot is missing. I added the *dynamic overshoot* with dotted lines in Fig. 11.

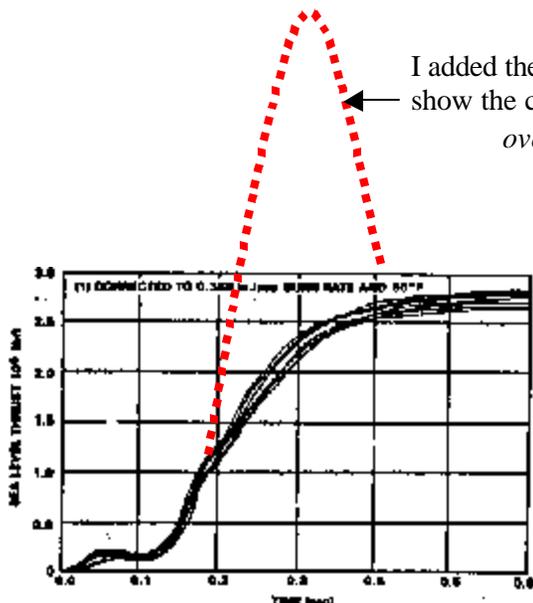
Fig. 12a *Transient Thrust Tests* of 26 Motors by Thiokol. *No Overshoot*.

I said that the *transient* error is widespread. The manufacturer of the Solid Rocket Motors (SRM), Morton Thiokol, also completely overlooked the dynamic overshoot in their analysis and tests. The SRM thrust was found by tests to be approximately 2.7 million lb[29]. The Thiokol test results are reproduced in Fig. 12a. The maximum thrust is reached in less than ½ second. Here, you see that none of the tests showed the *dynamic overshoot*, which was so clearly detected in two million tests of model rockets, see Fig. 5.

The Thiokol thrust-time traces for two-minutes-flight-burn is reproduced in Fig. 12b. The dynamic overshoot is completely missing.

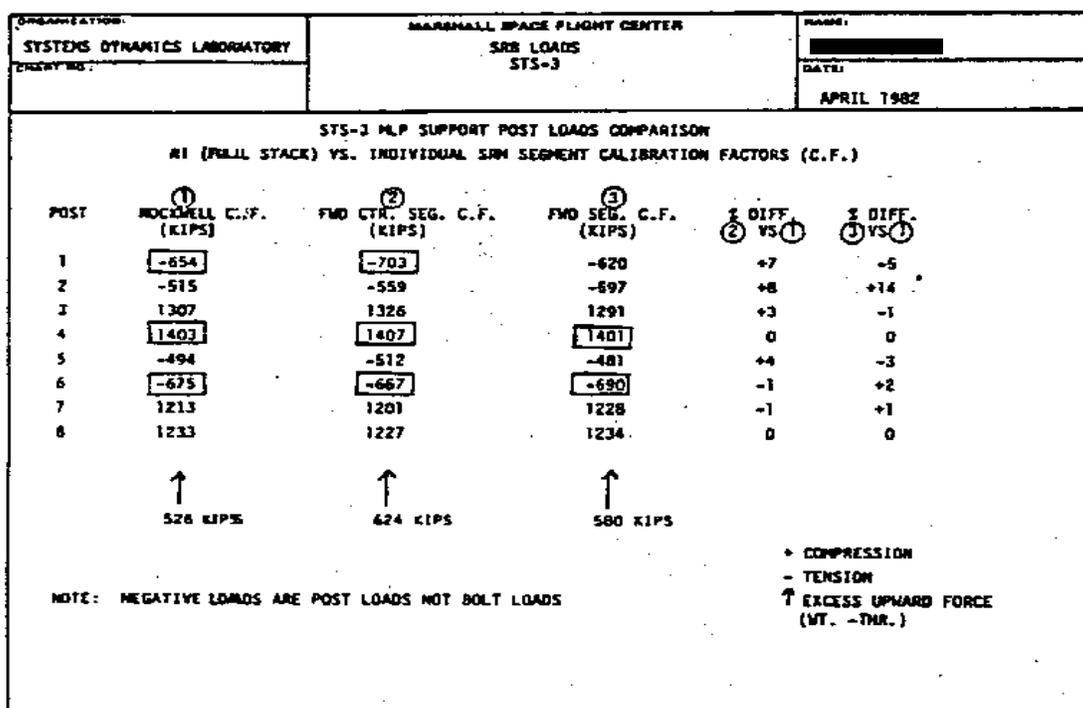
Fig. 15 *Dynamic Overshoot* **Measured in April 1982. Effect was described by Test Engineers as "- EXCESS UPWARD FORCE"!**

Some officers involved in the Space Shuttle Program asked me how to derive the dynamic overshoot from the STS-3 measurement in Fig. 15. The calculations are given in detail next.

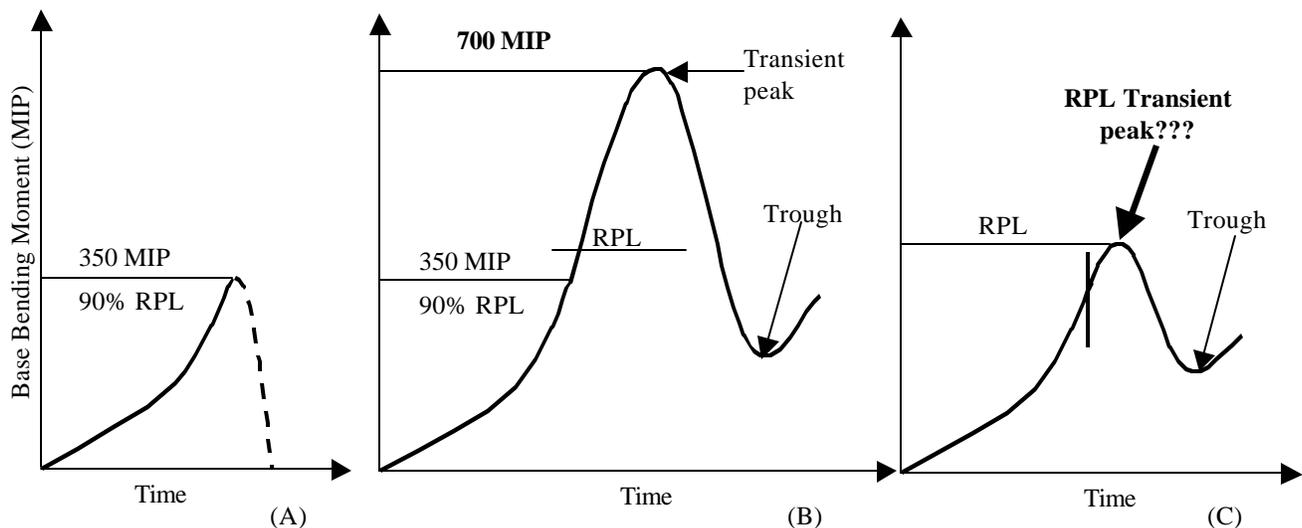
Fig. 22 Delayed Shuttle Lift-off Created Problems

The Shuttle engineers were satisfied with the lift-off time-delay because it reduced the base bending moment at lift-off from the 90% level to a trough value. But, no one noticed the basic fact that before the Shuttle reaches the new trough, it must first go through a new, unexpected and unaccounted for, peak! The initial 1972 mistake with the *dynamic overshoot* was *compounded.* You can begin to see how the hodgepodge base bending moment values in Table 13 came about. You can see what happened in Fig. 22.

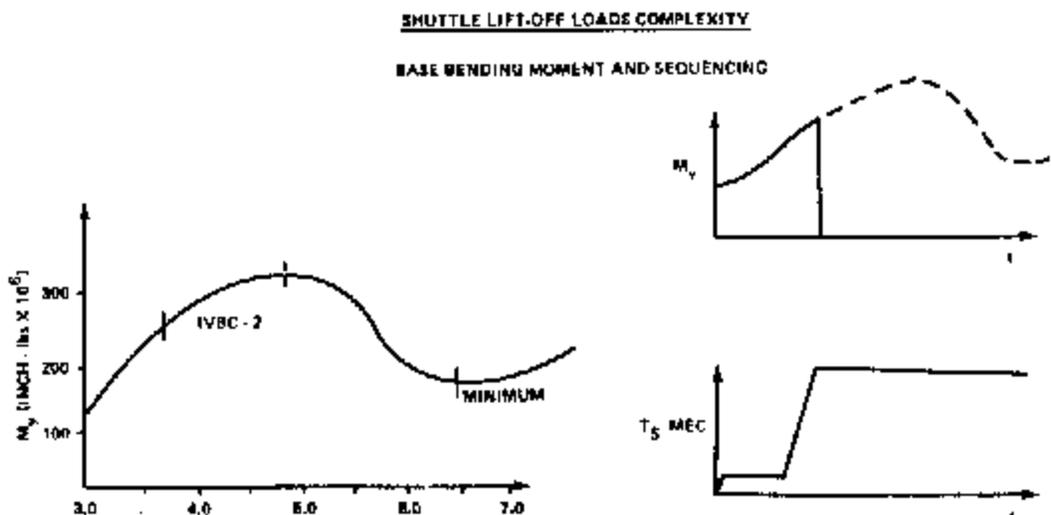
Fig. 26 1981 Illustration of base bending moment *transient* solution by 5 NASA experts. Notice how *transient* peak does not reach the steady-state value!

"*Problems Experienced and Envisioned for Dynamical Physical Systems*,"[33] in 1985, (p. 58). That was long after the "excess upward force" was measured from the STS-3 lift-off data in 1982. *Liftoff dynamics* presented problems to the *dynamics* experts at NASA and the Shuttle Contractors.

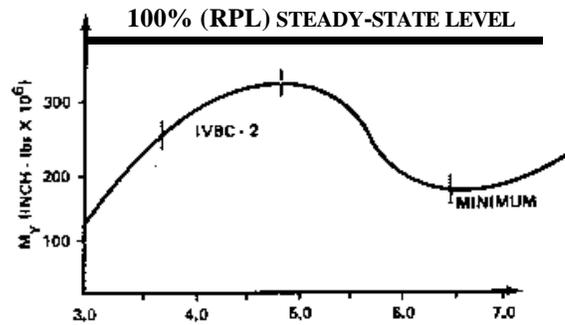
Fig. 27 NASA Transient Peak Falls Below Steady-State Static Value

4. The vertical markers at 3.8, 4.8 and 6.4 seconds correspond to (1) 90% SSME thrust (the abandoned lift-off condition), (2) the peak moment, and (3) minimum moment, respectively. The 90% SSME's throttle level had no useful meaning or use in the 1980s, but for some reason, this value seems to mean something to the Shuttle engineers, as it is always included in their graphic illustrations. It is included as a badge of honor, when it categorically proves the dynamic overshoot blunder.

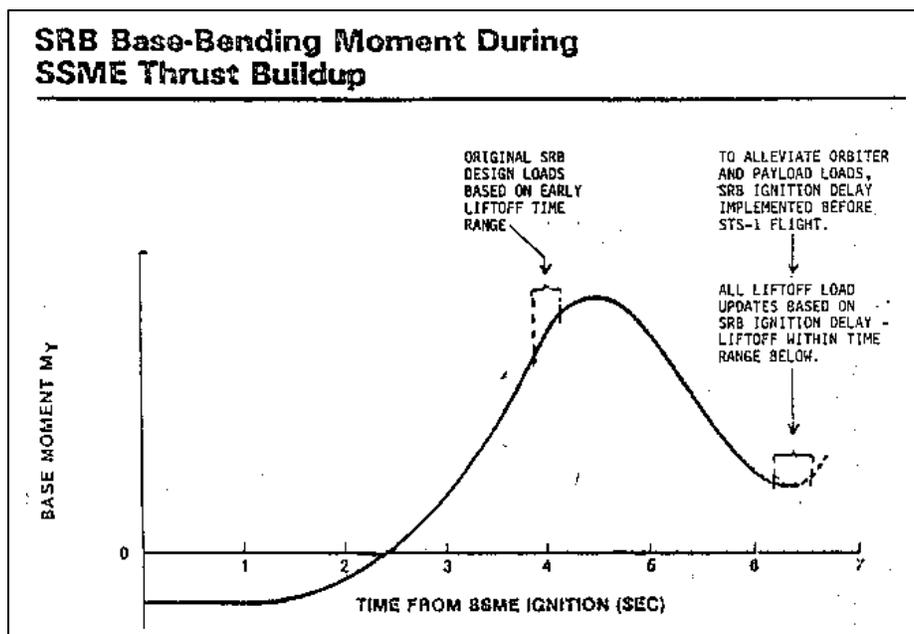
Fig. 29A 1989 NASA Base Bending Moment
Illustration Shows No *Dynamic Overshoot*!

At first glance, the 1989 *transient* illustration, Fig. 29A, appeared better than previous illustrations. Here, you see a smooth rise to a peak. Did they get it? No. The 1989 illustration was as mediocre as the earlier presentations by NASA and the Shuttle contractors. Let me explain.

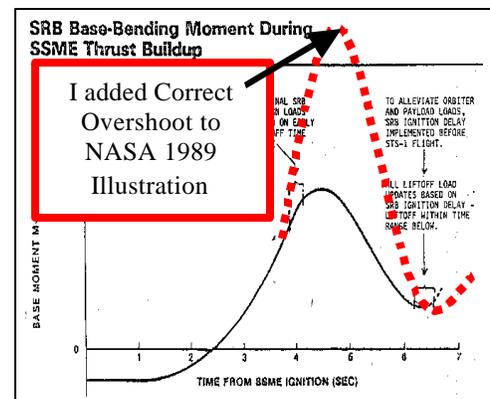
Fig. 29B 1989 NASA Base Bending Moment Illustration with the Correct Dynamic Overshoot

The correct *transient peak* should be TWICE (or DOUBLE) the value at the 90% SSMEs throttle. You can use a plain ruler to see that the *correct transient peak* must rise to the NASA title in Fig. 29A. Try it. You will get the dotted line in Fig. 29B. These were the same engineers who measured a 73% dynamic overshoot for the SSMEs in 1982. The base bending moment does not happen in a vacuum. The base bending moment (or torque) is the result of the thrust from the SSMEs. If the SSMEs' thrust overshoots, then the bending moment overshoots. If the SSMEs' thrust went from 90% to 100%, then the effect of the thrust is nearly doubled. If the SSMEs' thrust went from 90% to 100%, then the base bending moment is doubled. It is that simple. The fact that NASA and Rockwell used the correct (underline: doubled) base bending moment in the 1990 specifications, and even before, does not mean that the experts had a clear idea why the specification was underline: doubled in the first place. As late as 1989, the NASA dynamics experts still had no idea of how to correctly illustrate the start-up transient behavior in the Space Shuttle.

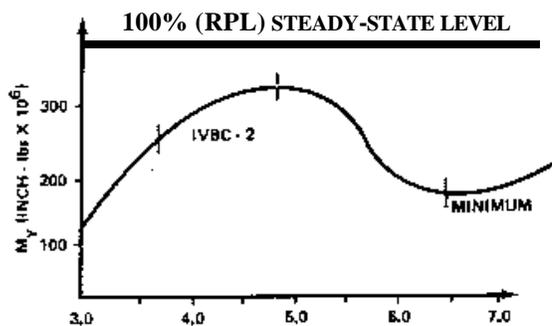
**Fig. 27 NASA Transient Peak Falls Below
Steady-State Static Value**

dynamic transient load is something that happens independent of the static load.

The NASA author of Figs. 26 and 27 writes in his 1985 detailed Dynamics Report, under the heading "Liftoff Transient Loads,"[33] the following, *"The Space Shuttle and its payload experience a very large transient load at liftoff due to a large asymmetrical coupling (static and dynamic)."* When you "couple" the static load (Sketch 1, Fig. 31) and the dynamic component (Sketch 2, Fig. 31), you get the transient response shown in Sketch 3 in Fig. 31. What were the NASA experts doing coupling the static and dynamic loads to obtain the result in Sketch 2 of Fig. 31, or its equivalent in their Fig. 27? What were they thinking?

We know that the maximum base bending moment is about 700 MIP. The maximum static base bending moment for the Shuttle is about 370 MIP. The NASA peak transient in Fig. 27 is about 330 MIP. Is it possible that the Shuttle experts just simply failed to add the two values? Let us add the two values:

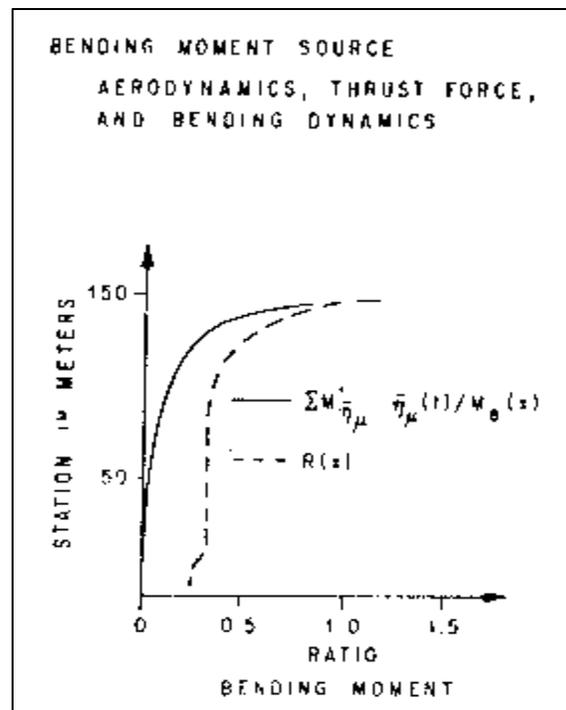
Fig. 32 Ratio of dynamic to total moment betrays lack of knowledge of correct transient effect since 1973

Can the ratio of the "*bending dynamics divided by the total bending moment*" approach 1.0? Can the ratio of the overshoot on a weight-scale divided by the total force on the scale approach 1.0? <u>The ratio</u> the NASA experts wrote about in 1973 CAN NEVER BE GREATER THAN 0.50!

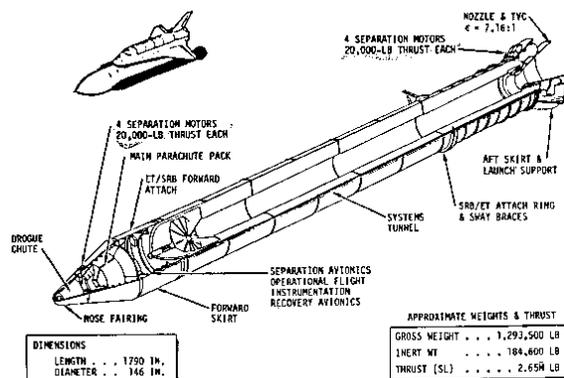
Fig. 34 Everything needed to calculate Axial Force in A Booster

That's it. Our result, 15.2 million lb, is not shabby. It agrees with the NASA and the Commission va lues. The calculation is shown inside the circle of a booster cross-section in Fig. 34.

The damping ratio for the boosters is about 0.01. I calculated the *overshoot* factor to be 96.9%, see Table -2. In rejecting my *dynamic overshoot* papers[38] submitted for publication, the peer-reviewers of the *Journal of Spacecraft and Rockets* said that the damping ratio is 0.015. OK, let us calculate the *overshoot* factor for their damping ratio. The *overshoot* factor for their

"0.015 ratio" is 95.4%. That issue settled, what is the *maximum* axial force in a booster? Let us calculate it for my factor and their factor:

Peak Axial Transient Force (0.010 damping ratio) $\approx 15.2 \times 10^6 \times 1.969 = 29.9$ million lb
Peak Axial Transient Force (0.015 damping ratio) $\approx 15.2 \times 10^6 \times 1.954 = 29.7$ million lb

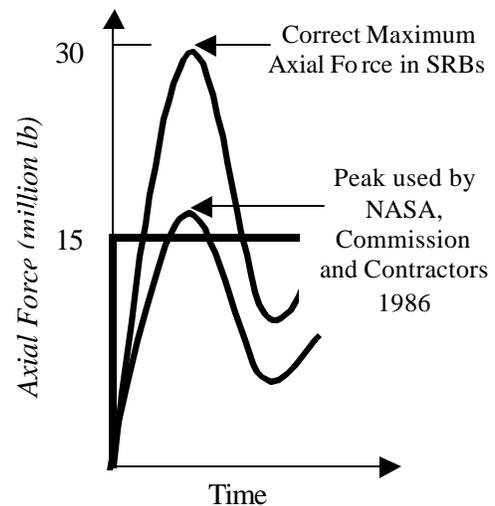
Fig. 35B Maximum Axial Force is 30, and NOT 16.7, million lb

The axial force (16.7 MP) used by this NASA/Industry team falls between the NASA 1990 specification value (15.3 MP) and the design limit load (17.2 MP). We know that this is the static force. It does not contain the transient force component. It does not include any transient effect. It does not include the correct dynamic overshoot factor. With the overshoot, the axial force is about 30 MP. If the engineers or

the peer-reviewers made the simple sketch shown in Fig. 35B, they would have discovered with one look that the Peak Axial Force used in the above research is terribly wrong. The missing and enormous overshoot is not "*a non-existent, fictitious 'problem'*", as the AIAA reviewers said. Yet, the NASA/Industry paper received the blessing of the peer-reviewers, and was published. More importantly, the actual Shuttle SRBs continue to be grossly underdesigned after the Challenger accident.

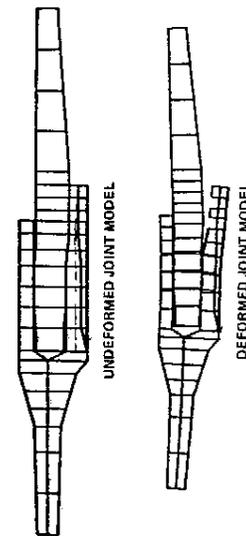
Fig. 38 Finite -element-models of deformed and undeformed joints

The NASA finite-element computer models of the deformed and undeformed joint are shown in Fig. 38. When the transient pressure build-up in the boosters reaches the joint in the left model, the joint deflects (opens) as shown on the right side of the figure. Detailed analysis of joint rotation and design is given in my other papers on the subject. Here, I will stay with the grossly inaccurate <u>transient</u> analysis of the joint by NASA and the Contractors. When you review the thousands of illustrations of the SRB joint-rotations and joint-deflections generated before, during and after the Challenger investigations, you will think that the scientists and engineers have never heard about something called dynamic overshoot. Not one single illustration includes the destructive dynamic overshoot effect.

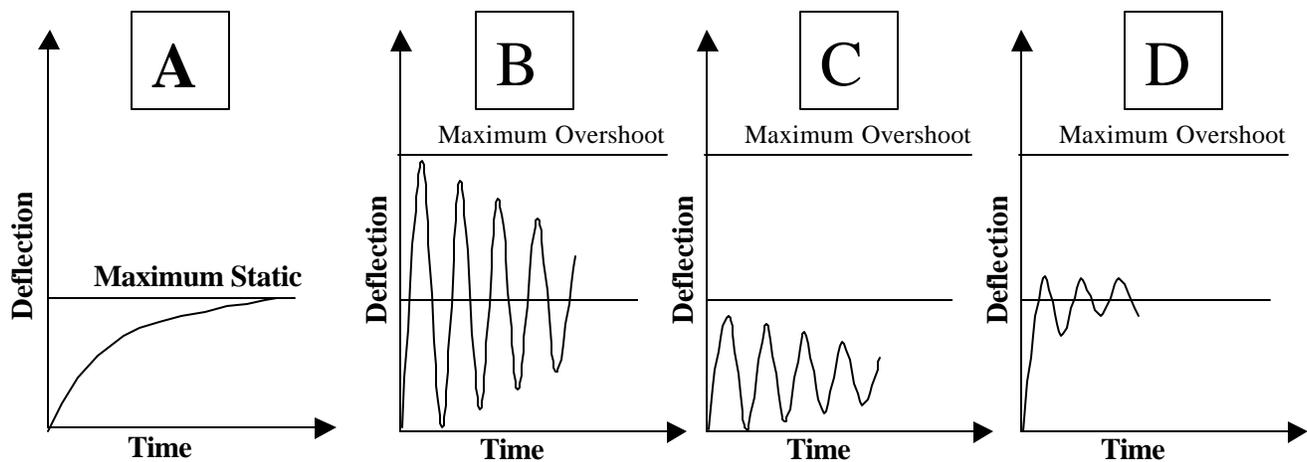
Fig. 41 (A) Correct Static Deflection, (B) Correct Transient, (C) Wrong Transient, and (D) Wrong Transient

The pointer on a simple 2-lb postal scale deflects a total of 4 inches. Everyone can get a 1-lb weight and try the correct static deflection and the correct dynamic overshoot on the scale in their homes or offices. If you release the weight gradually, you will see something similar to sketch A in Fig. 41. If you release the weight suddenly, you get sketch B in Fig. 41. You can try a variety of tricks to induce Sketches C and D, but you will not be able to reproduce these responses.

The SRM Team, that developed the incorrect transient solution in Fig. 40, apparently consider the static, or what they call quasi-static; Sketch A in Fig. 41 to be a dynamic response. Look, try the 1-lb weight on the 2-lb postal scale again. Release the weight slowly and, either, envision Sketch A or draw it. The pointer will move only 2 inches. Release the weight suddenly; the pointer will deflect beyond 2 inches. This repetitious and boring exercise is specifically designed for the executives who do not have the time to examine the lengthy static-dynamic-transient analyses of their subordinates. If you correct the massive mistake by the befuddled few, you will benefit the many dedicated workers in your organization.

How can sketch A in Fig. 41 or the SRM Team's Fig. 40 be dynamic? If the ordinate in Sketch A were the speed of a car, then the Sketch is a dynamic situation. But the SRB's joint rotation, the postal scale deflection and the slinky deflection are not going anywhere. These are static situations. These are not dynamic situations. Sketch A, Fig. 41, has nothing to do with dynamic transient analysis or responses.

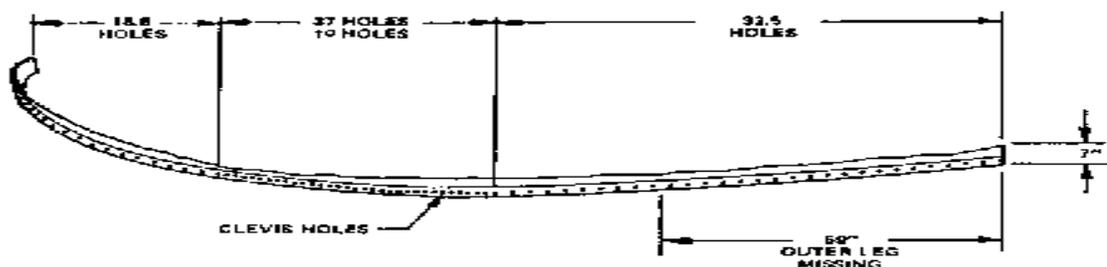
Fig. 44 NASA Sketch of Recovered Challenger Forward Skirt Clevis Joint

To the Shuttle engineers, the 3-SSMEs produce about 1.1 million pounds and each SRB produces 2.7 MP force at lift-off. But, we showed that with the correct dynamic overshoot, the peak transient lift-off forces are nearly doubled. The attachment between the SRB forward skirt and the External Tank carries the brunt of the forces from the engines and the boosters at lift-off. Was the dynamic overshoot effect taken into account in the initial design? No. The oversight necessitated doubling the number of pins in the area most affected by the dynamic overshoot.

As I walked into the Vehicle Assembly Building (VAB) at the Kennedy Space Center in October 1986, I was shocked to see a booster section that had extra one-inch holes added between the original holes in an angular sector of about 30°. The new 1-inch holes were added in the 1½-inch spacing between the original holes. That left about ½ inches spacing, or ¼ (0.25) inch spacing on each side of the new holes. You can see the extra holes in a NASA artist sketch[30] of the recovered Challenger Forward Skirt Clevis Joint in Fig. 44. The SRB section with the extra holes was in plain view in the VAB. That SRB section was seen by thousands of engineers, scientists, investigators, politicians and reporters since the Challenger tragedy. The scene did not shock anyone. It shocked me. That was a clear fingerprint of the dynamic overshoot.

Showing the Extra Holes

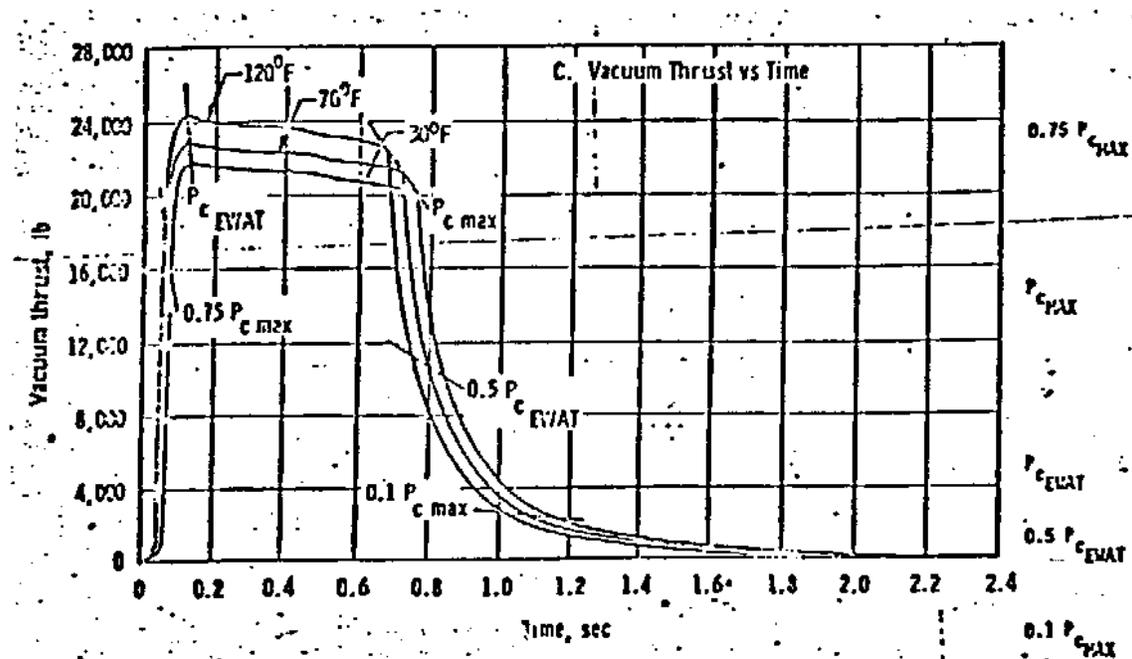
Fig. 48 BSM Thrust Profile Showing a Peak of only 24,000 lb. A DLF of only 6.5%

The steady-state thrust for each BSM is 22,300 lb (Ref. 28, Sec. 4.14). Initially, the BSM design thrust was specified to be 23,750 lb, or a dynamic factor (now called DLF) of only 6.5%, which is in the same mistaken ballpark of values used for the SSMEs, SRBs, etc. The initial and mistaken BSM thrust profile, with the smaller DLF, appeared in the same 1990 Loads Books, see Fig. 48. The dynamic overshoot, or the DLF, is only 6.5%. It is as if a typist had forgotten to remove the telltale curves from the specification books. This lapse made it possible to reconstruct how the DLF was increased from 6.5% to 100%.

Notice how the thrust is given in pounds on the left ordinate. The corresponding pressure values appear on the right side. This confirms my earlier observation that the Shuttle engineers measure the pressure and convert the non-overshooting pressure values to thrust values without deriving the correct transient response, with the correct dynamic overshoot.

It is relevant to note here that the shape of the BSM thrust profiles in Fig. 48 is similar, even identical, to the thrust profiles found in engineering textbooks on propulsion systems, e.g., Ref. 8, "*Rocket Propulsion Elements*," pp. 267, 273 and 318. The same thrust shapes are also found in Wernher von Braun's and others' books. All of the above thrust profiles show only less than 10% load amplification during the start-up transient period. And none of the books explain how the small dynamic factors were derived in the first place. It can be said that the correct dynamic overshoot factors were neglected in the design of all space systems, including the Space Shuttle, which resulted in completely inadequate designs since the beginning of the space program. Do you remember the exploding rockets of the 1960s, 50s and 40s?

1. Initially, a grossly inadequate dynamic factor of 6.5% was used in BSM design.
2. Graphic illustration of the transient response (Fig. 48) was wrong, even though the illustration followed the practice used in engineering textbooks.
3. Extensive structural damage, which could easily be explained to be the result of the "excess forces" during the ignition transient, was mistakenly attributed to splashdown into the ocean.

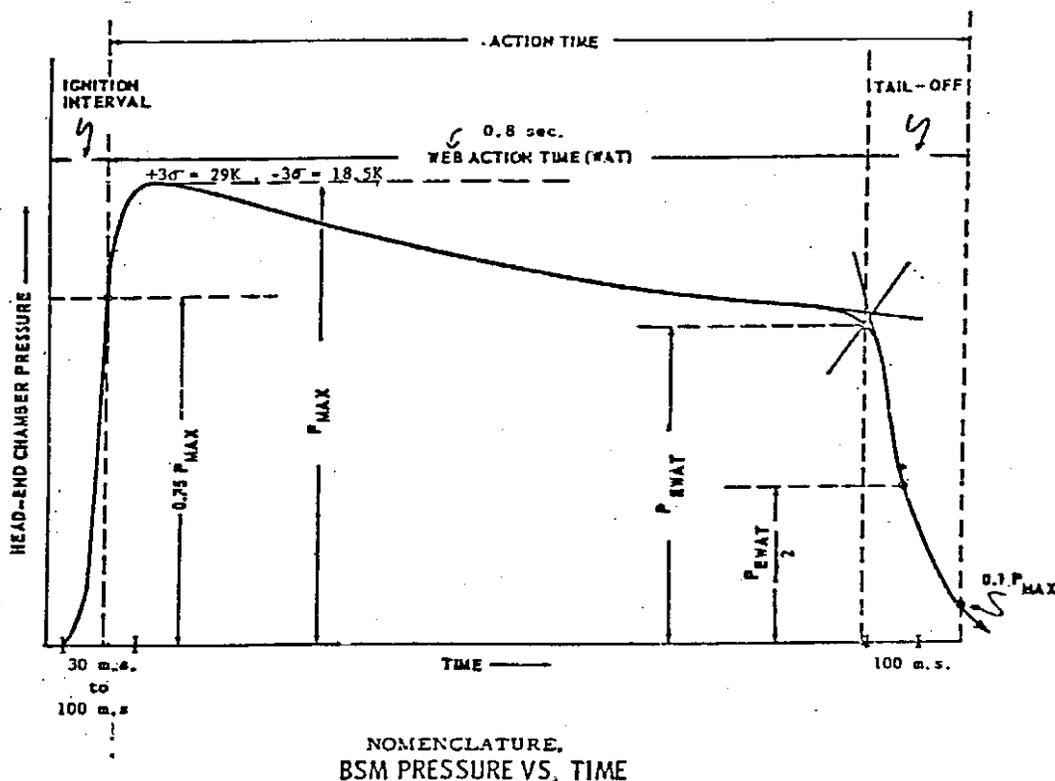
Fig. 49 NASA 1990 BSM 3s Overshoot Peak of only 29,000 lb. <u>A DLF of 30%</u>

Apparently, the convoluted statistical 3-sigma method (see quote, p. 46) was then used to increase the BSM design loads. The 3-sigma factor produced a greater design load, which is shown in Fig. 49. Notice, in particular, that the design peak load is marked, "+3σ = 29K," or 29,000 lb. This is another telltale sign

of the changing DLF for the separation motors. The illustration is another confused Shuttle transient response. Here, the dynamic factor becomes 30% (i.e., 29,000/22,300), instead of the initial 6.5%. The 1990 specification curve in Fig. 49 indicates that, at some point, the engineers believed the peak load to be this 29,000-lb value. Again, the general shape of the transient overshoot response is wrong – see my earlier transient overshoot illustrations or the model rocket response in Fig. 5.

I emphasized repeatedly how the Shuttle engineers, and others, measure the pressure (which does not overshoot) and convert the non-overshooting pressure values to force values. The force-overshoot is then missed altogether. I also said the experts use the pressure-time curves as the FORCING FUNCTION in transient analysis, which is wrong. For, again, how can the FORCING FUNCTION be in pounds-per-square-inch and the TRANSIENT RESPONSE in pounds? This is mixing apples and oranges. The NASA 1990 Fig. 49 shows it all. With the exception of the peak force marked "+3σ = 29K," everything in Fig. 49 is in pressure units! The confusion over the dynamic overshoot concept is abundantly clear here.

5. The new graphic illustration of the transient response (Fig. 49) is also wrong. Here, the transient response is given in pressure units, which should be the Input, not the Output, in transient analysis.

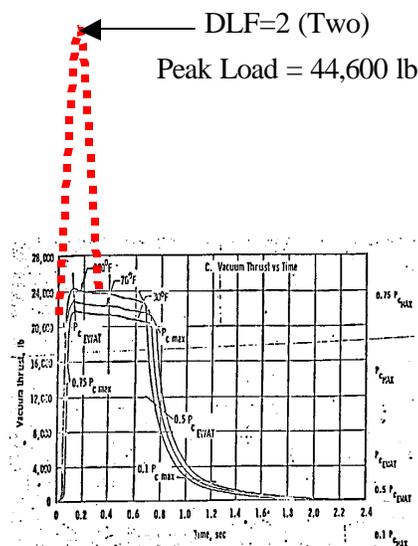
**Fig. 50 Correct DLF Effect
Added to BSM Thrust**

I have added the approximate correct dynamic overshoot effect for the Booster Separation Motors to the NASA 1990 illustrations (Figs. 48 and 49) in Figs. 50 and 51, with the provision that the ordinate in Fig. 51 be specifically marked with <u>thrust</u>, and <u>not pressure</u>, values.

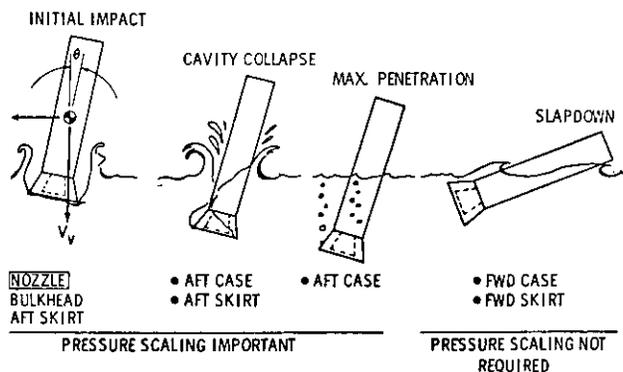
Fig. 53 Booster splashdown

Subsequent to the demoralizing STS-6 damage experience, the fickle splashdown solution and the inordinate analyses and further tests of splashdown were described in detail in the 1985 NASA Technical Paper[33] on "*dynamical problems.*" This was two years after earlier extensive studies had dismissed splashdown altogether. A NASA schematic of the splashdown is shown in Fig. 53.

Figure 69. SRB water impact significant loading events.

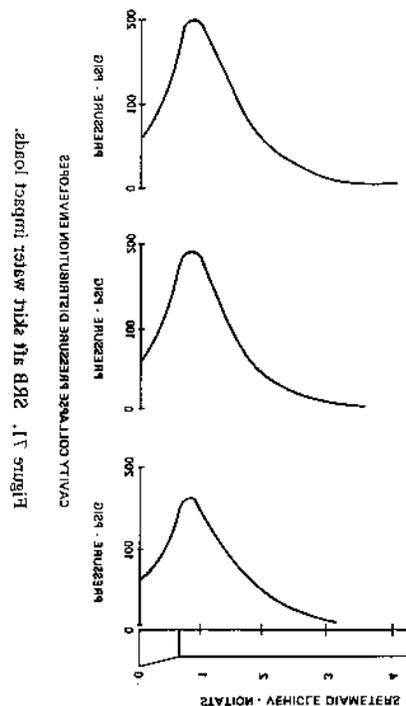
Fig. 54 Splashdown Analyses Show No dynamic Overshoot

You can see another sample of the wrong transient responses in Fig. 54, where the NASA expert omits the correct dynamic overshoot in splashdown loads. I inverted the curves to keep the figure consistent with the other figures. Notice that the ordinates give the non-overshooting pressure values! This means that there was no differentiation between the Input and the Output in the transient analysis. Also, notice that the maximum splashdown pressure is less than 200 psi, which is much smaller than the start-up lift-off pressure in the boosters, of nearly 1,000 psi. The reader can add his or her own estimate of the correct maximum dynamic overshoot to the NASA 1985 curves in Fig. 54.

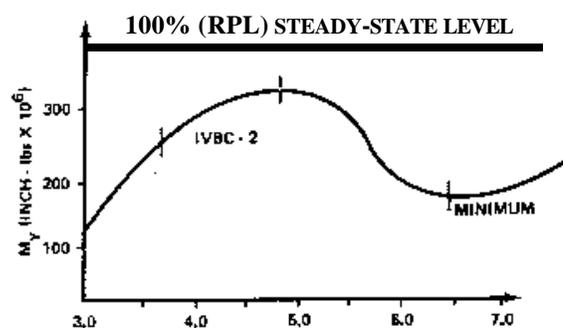
Fig. 27 NASA Transient Peak Falls Below Steady-State Static Value

5. The engineers show lack of familiarity with the start-up transient analysis. They believe that the loads rise up to only the 100% value. They know that transient responses oscillate. They do not know that the loads overshoot. They do not know that if there is no overshoot, there is no oscillation. They mix up the conflicting facts to produce the mediocre graph in Fig. 27. I added the 100% steady-state value to their Figure. By failing to identify the overshoot, the engineers attribute the problems to post-liftoff twang, or vibrations, than the pre-liftoff 100% overshoot.

6. The engineers note that the base bending moment M_y in their Fig. 27 is the "<u>primary driver</u>" for Hubble. As you see, the primary driver does not overshoot the 100% steady-state level, yet the curve in their illustration oscillates, which is impossible. So, when they discover that the Hubble Secondary Mirror

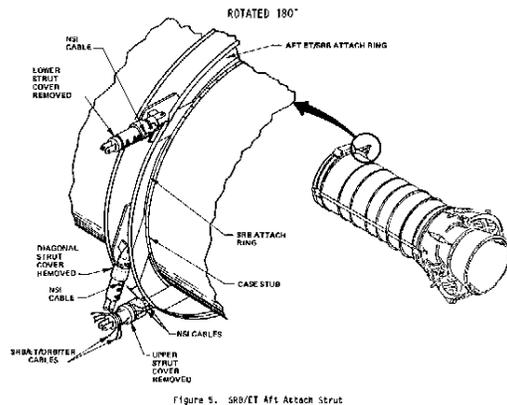
Fig. 61 Crack in Challenger Right Booster Aft Center Segment

One flight, and only one flight, the STS-6, rendered the booster aft segment useless. A crack in the failed booster segment was apparent to the investigators. The investigators blamed the failure on underline{flight splashdown.} STS-6 was the mission that the engineers made the all out effort to eliminate the mysterious 'splashdown" damage. The repairs did not work because splashdown was not the problem. The booster segments that failed on Challenger and in the Utah test were hit hard by the dynamic overshoot. The engineers, and subsequently the investigators of the Utah accident, did not notice the missing and detrimental dynamic overshoot loads.

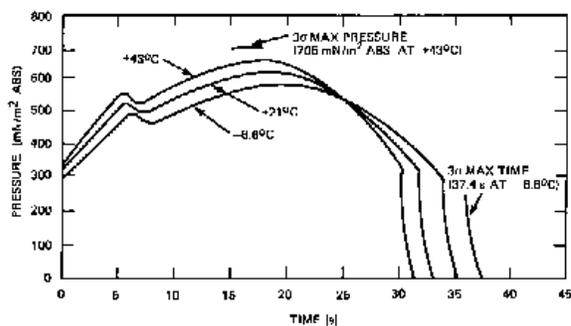
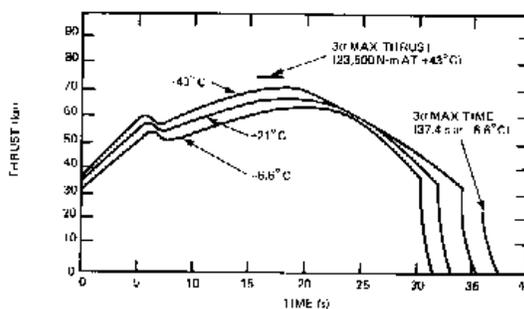
Fig. 66A Thrust Curves for INT-IV Apogee Motors (on right) show no Dynamic Overshoot. Notice in particular how pressure and force curves are identical.

Typical pressure-time and thrust-time traces for one apogee motor are shown in Fig. 66-A.[53] Here, you see the _pressure_ traces on the left, and the _force_ traces on the right. The start-up transient Input (or Action, Cause, or Forcing Function) in the left traces and the transient Output (or Reaction, Effect or Transient Response) in the right traces are identical. How can that be? Where is the dynamic overshoot? It does not exist. The same Contractors who manufacture the Shuttle SRBs also manufacture the apogee motors. In Fig. 66-A, you see the same mistaken trend that I described repeatedly in this Report. My co-workers and the other engineers simply convert pressure readouts to force values, incorrectly showing 0 (zero) start-up dynamic overshoot.

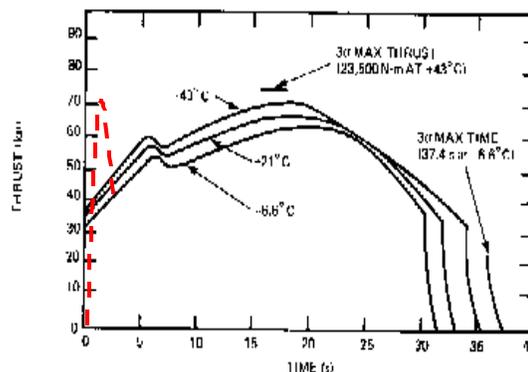
Fig. 66B INT-IV Apogee Motor Thrust.
Overshoot Added

The start-up dynamic overshoot is short lived. It happens suddenly, and then disappears. How should the correct Transient Response for the apogee motor look like? I show the start-up dynamic overshoot for this apogee motor in Fig. 66-B (red dashed line).

Notice how the burn pattern for the apogee motor is arranged such that the peak occurs midway through the burn. The dynamic overshoot is slightly greater than the peak pressure (or thrust) at the midway-burn-point. The middle peak barely corrected for the dynamic overshoot effect, but the engineers could not bring themselves to add the start-up dynamic overshoot effect outright. You see their "3σ MAX" dynamics for the non-overshooting pressure and the overshooting force in their figures!
